**MULTI-MEDIA COMPLIANCE EVALUATION INSPECTION
U.S. ENVIRONMENTAL PROTECTION AGENCY
REGION III
OFFICE OF ENFORCEMENT, COMPLIANCE, & ENVIRONMENTAL JUSTICE**

**American Zinc Recycling Corporation
(formerly Horsehead Corporation)
900 Delaware Ave
Palmerton, Pennsylvania 18071**

Inspection Dates: 14-18 May 2018

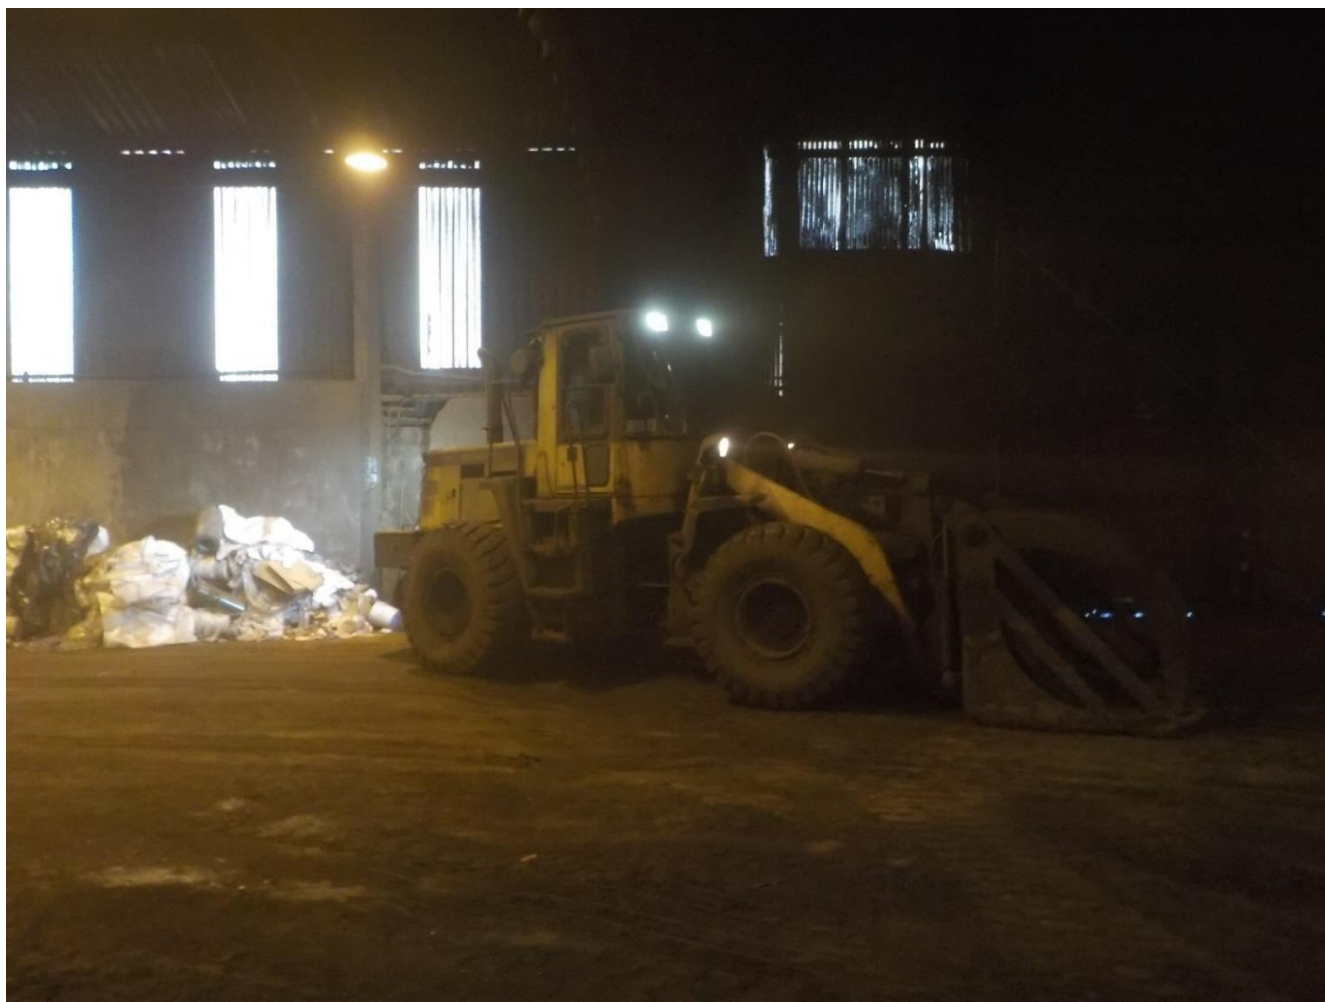
Photo 21. (DSCN0131) This photo shows a portion of the interior of Building 608, the RCRA-permitted storage building for EAF dust. This photo looks towards the southern wall of the building. In the center is a payloader utilized by the Facility to manage EAF dust. See also photos 18, 19, and 20.

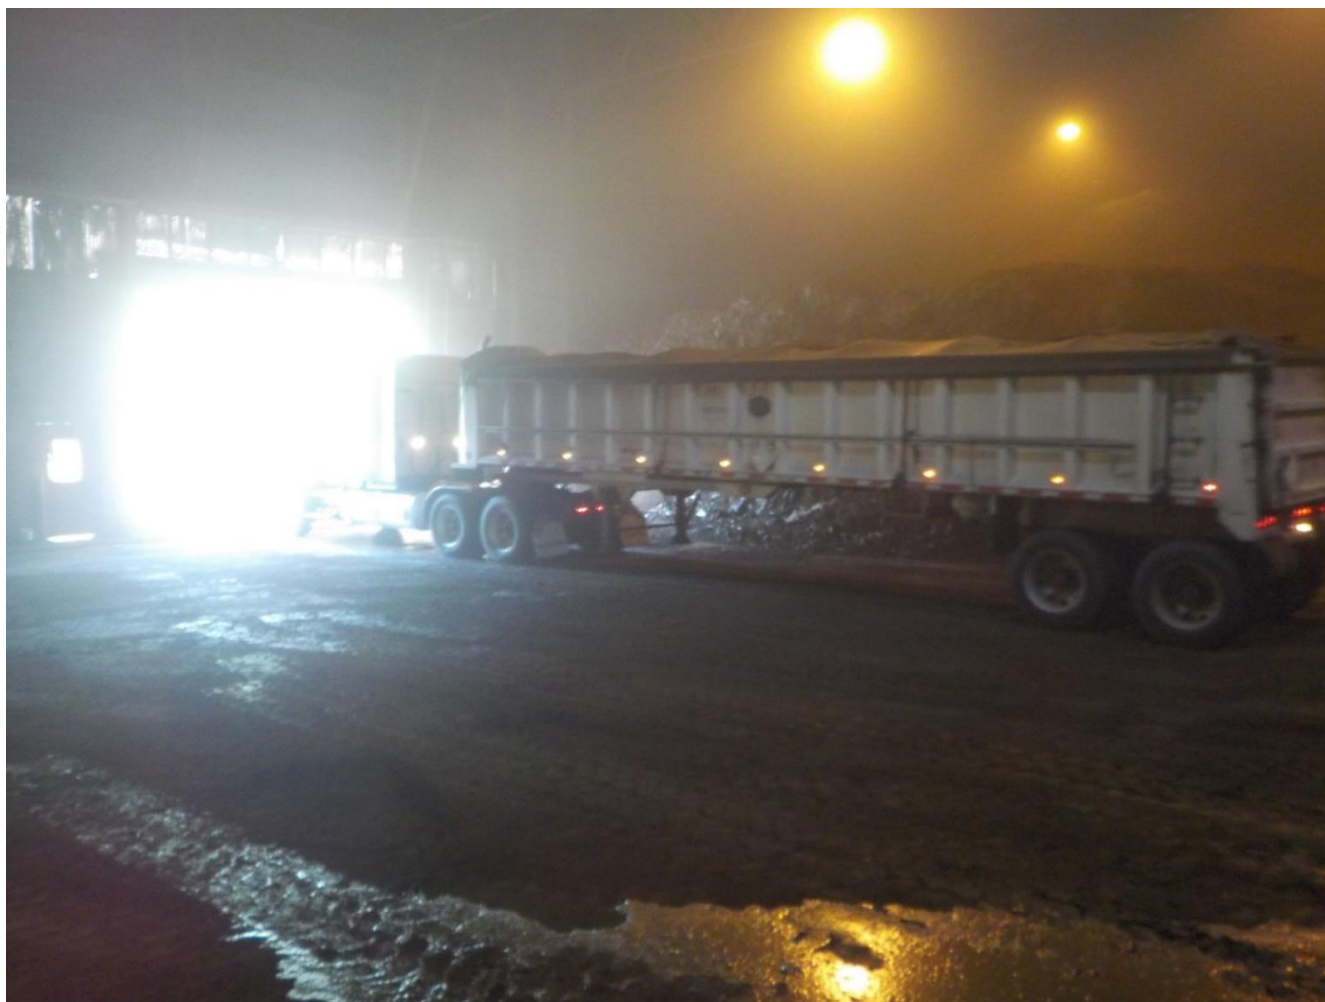
Photo 22 (DSCN0142) This photo shows a truck backing into Building 608, the RCRA-permitted storage building for EAF dust. See also Photo 23.

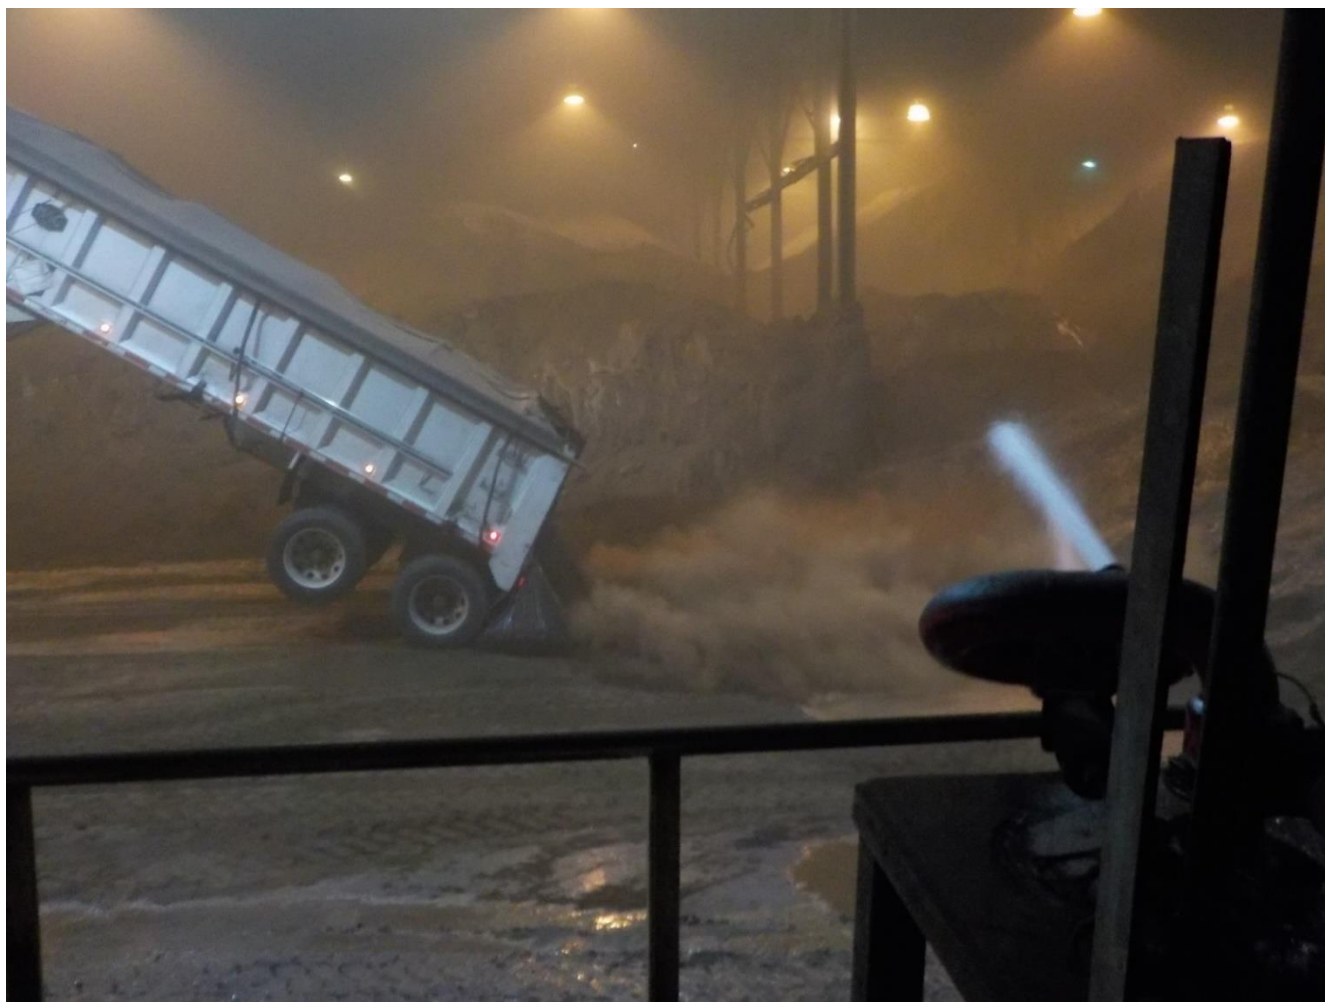
Photo 23. (DSCN0149) This photo shows the truck visible in Photo 22 dumping a load of EAF dust (brown cloud) inside Building 608, the RCRA-permitted storage building for EAF dust. The water cannon is visible at right in the foreground.

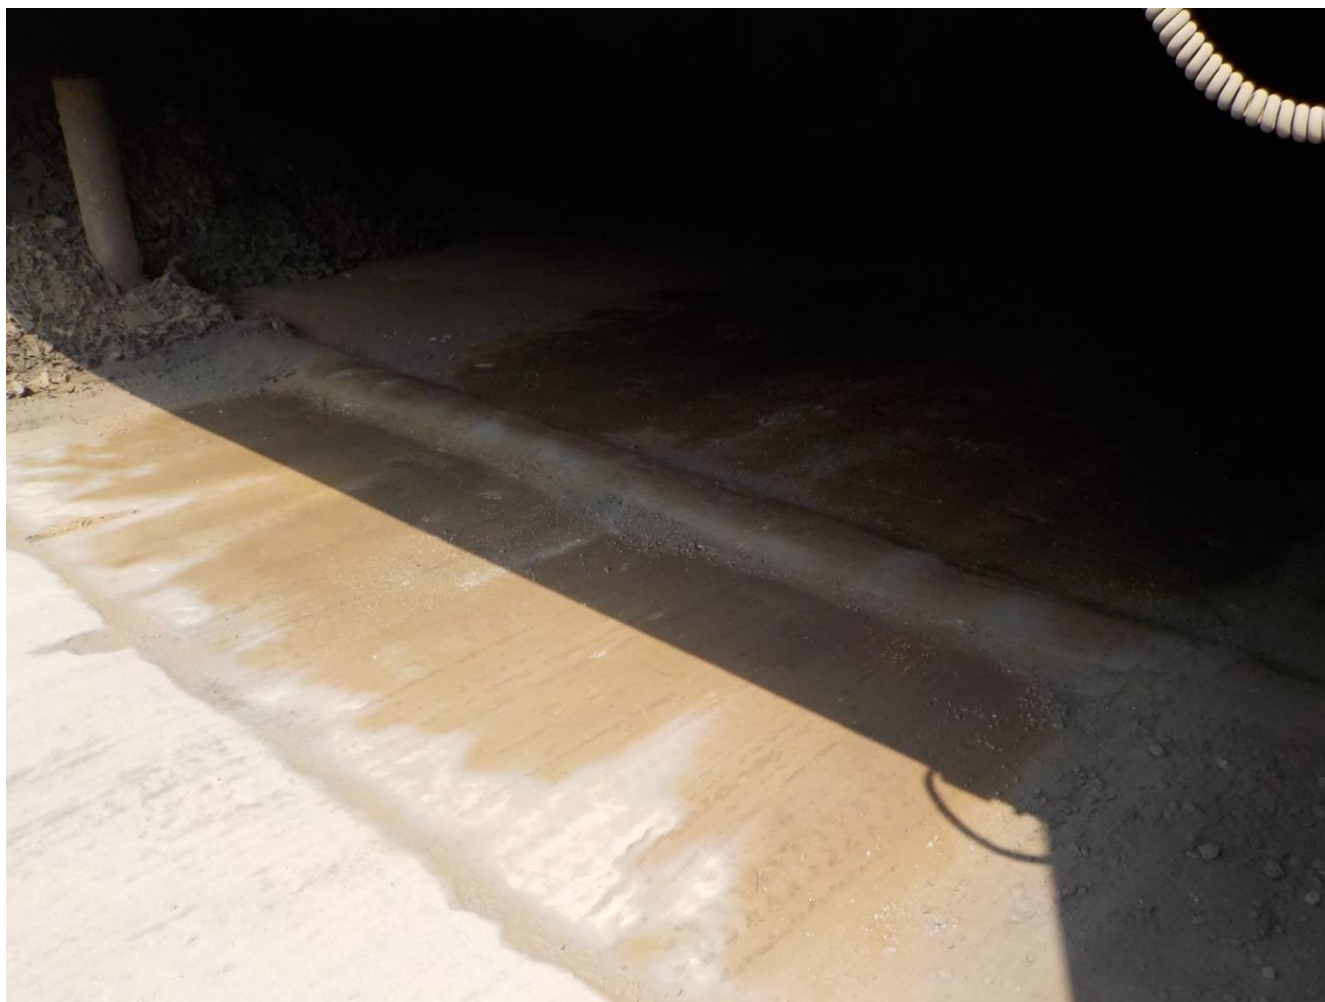
Photo 24. (DSCN0176) This photo was taken just outside the Building 608 truck entrance, and shows the low concrete berm in the threshold of the doorway. Note the brown fine-grained material on the pavement surface on the interior side and exterior side of the berm, and on top of the berm. See also Photo 25.

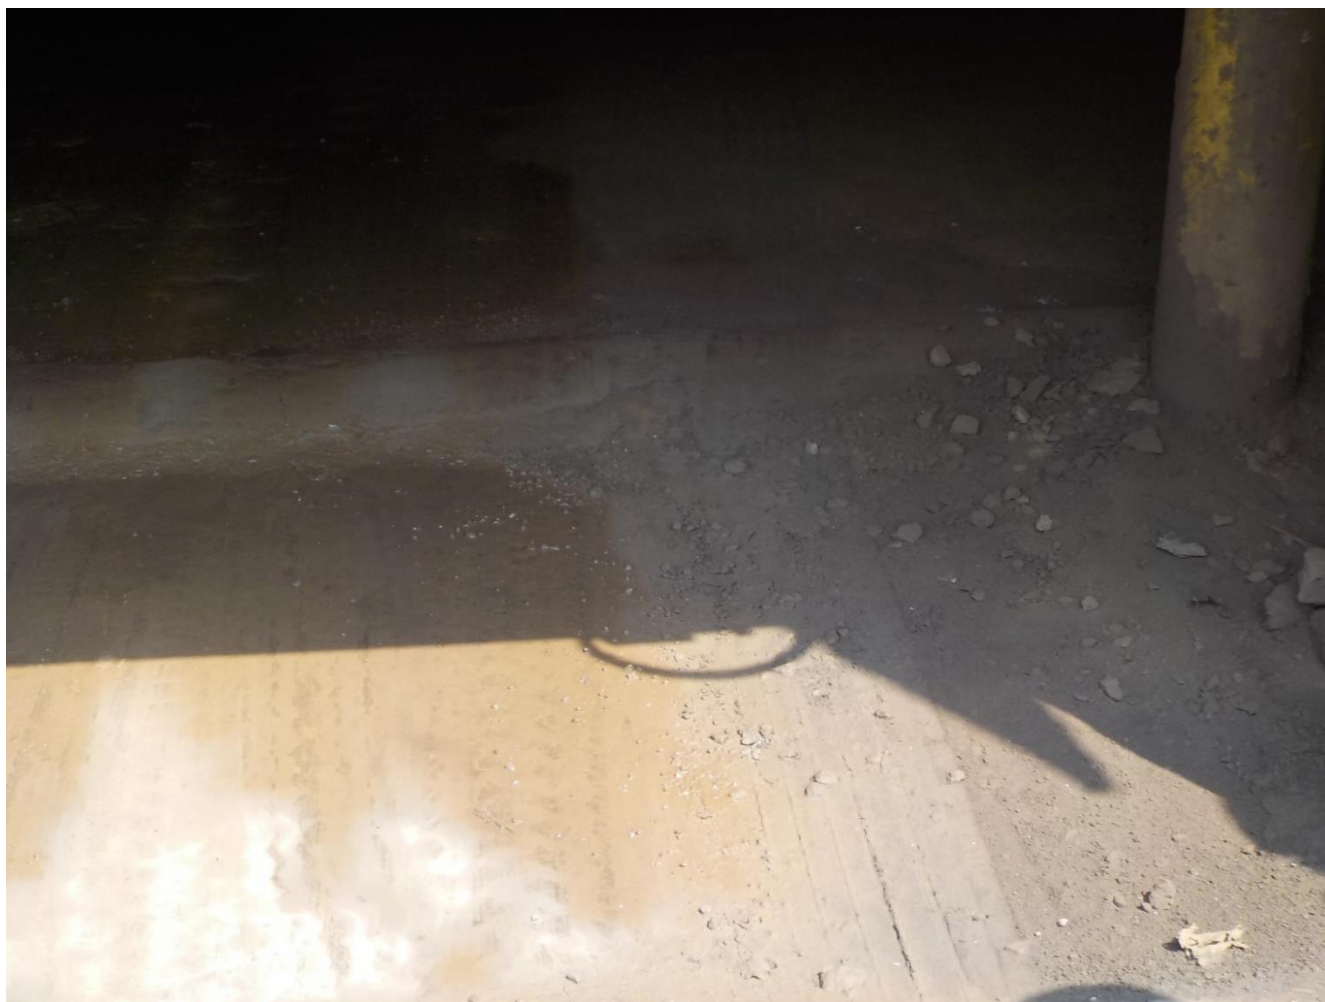
Photo 25. (DSCN0178) This photo, taken just outside the Building 608 truck entrance, shows the brown, fine-grained material on both sides of the berm in the doorway threshold. See also Photo 24.

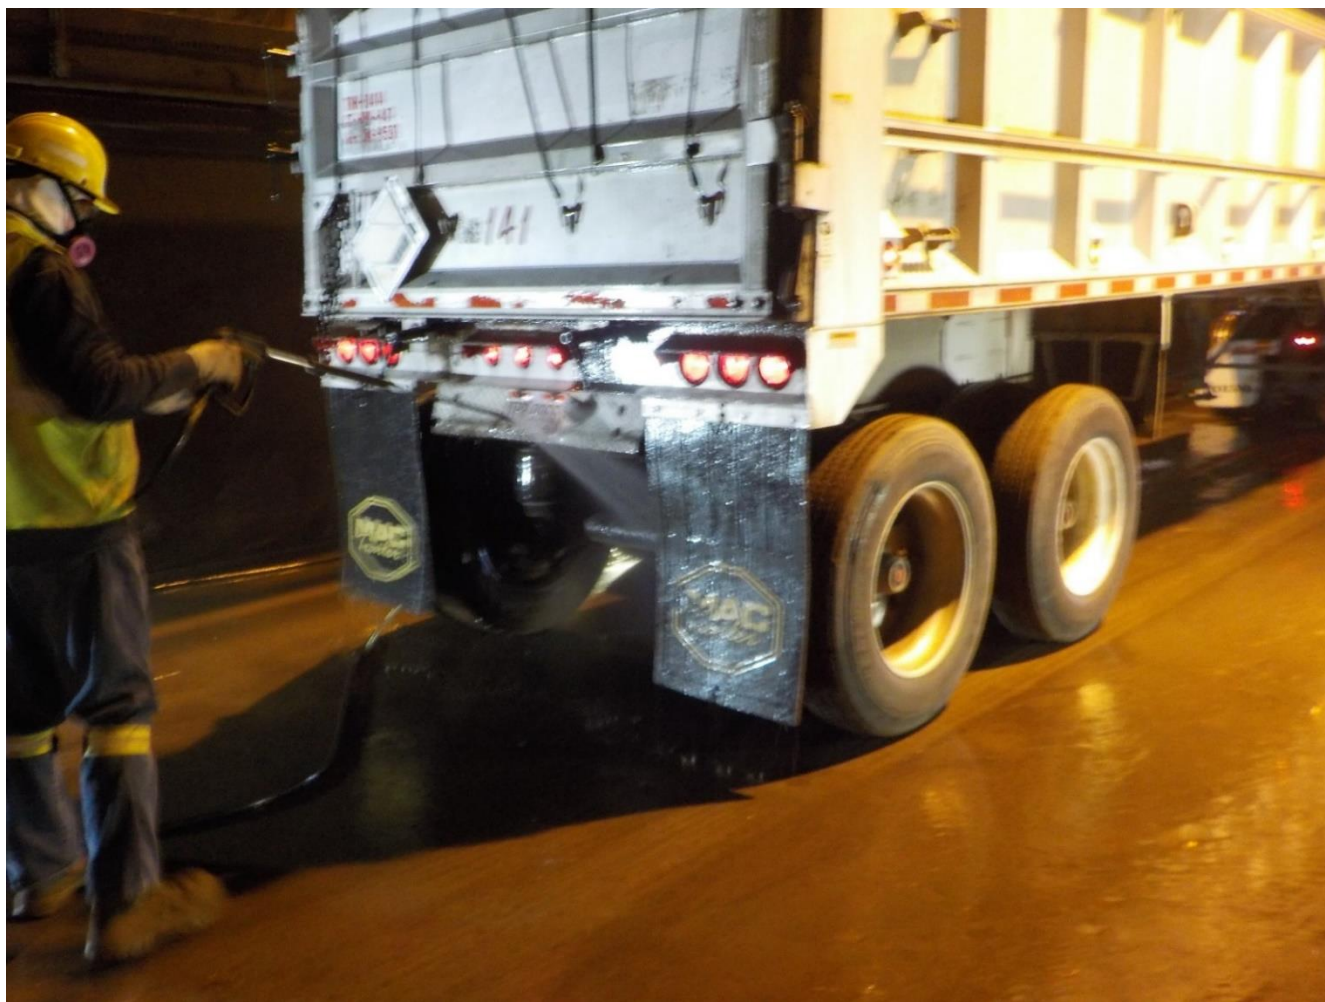
Photo 26. (DSCN0157) This photo, taken inside a truck wash bay (Building 624), shows a Facility employee using a pressure washer to spray the rear tires of a truck that just delivered a load of EAF dust in Building 608.

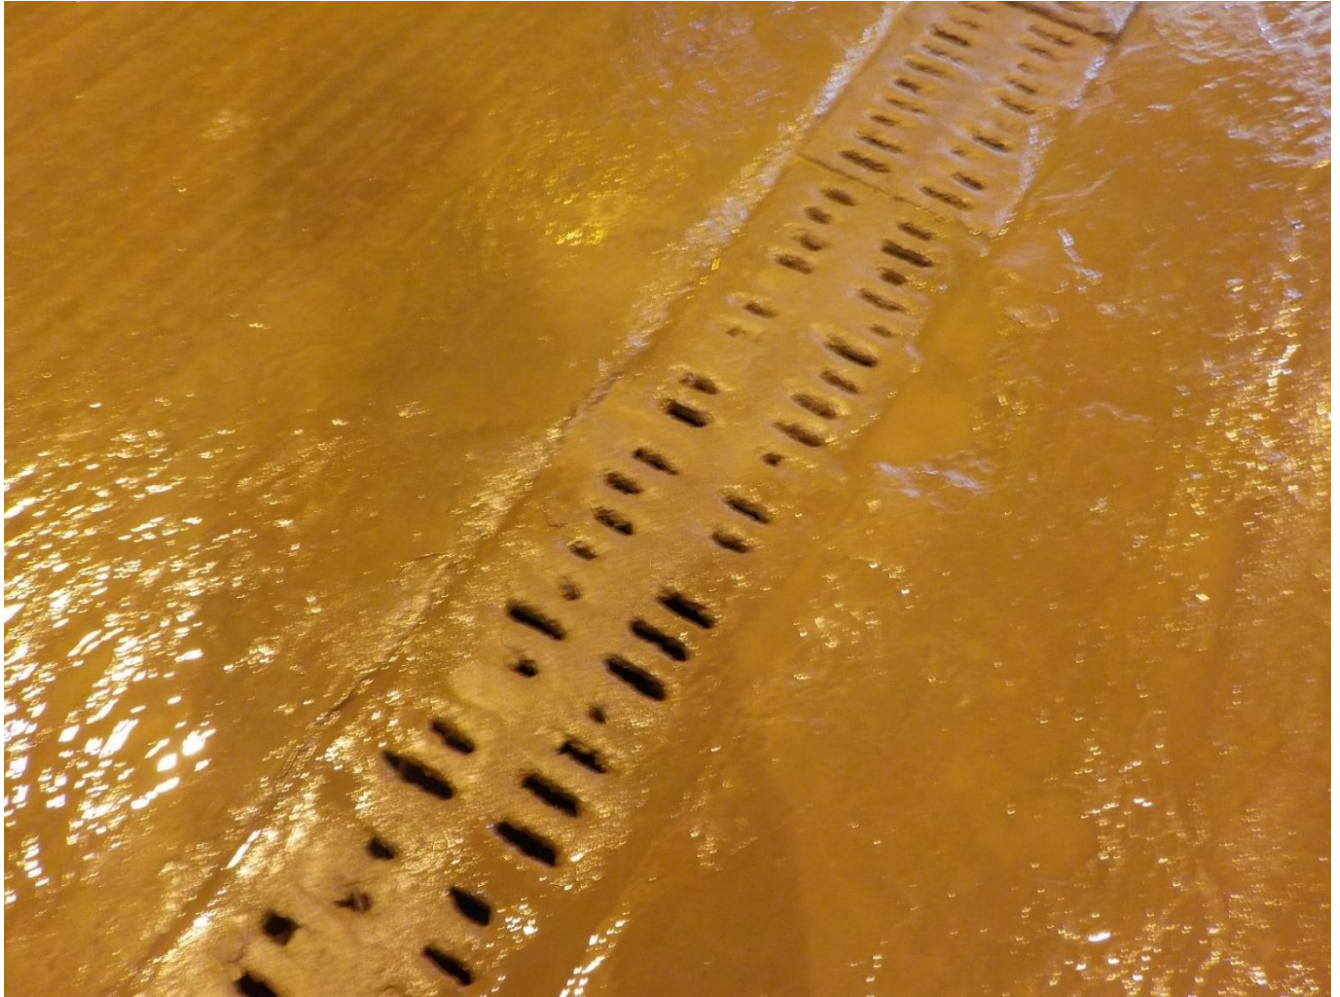
EPA inspectors Eller and Kline observed that dirty wash water draining into a T-shaped floor drain (see Photo 28). The metal grate to the floor drain appeared to be partially caked with wet EAF dust (see Photo 29). EPA inspector Eller inquired where the floor drain leads to, and Mr. Kunkle replied that dirty wash water drains by gravity into a circular holding tank in a room adjacent to the southern-most wash bay.

Photo 29. (DSCN0166) This photo shows a close-up view of a portion of the floor drain inside a truck wash bay in Building 624.. See also Photo 28.

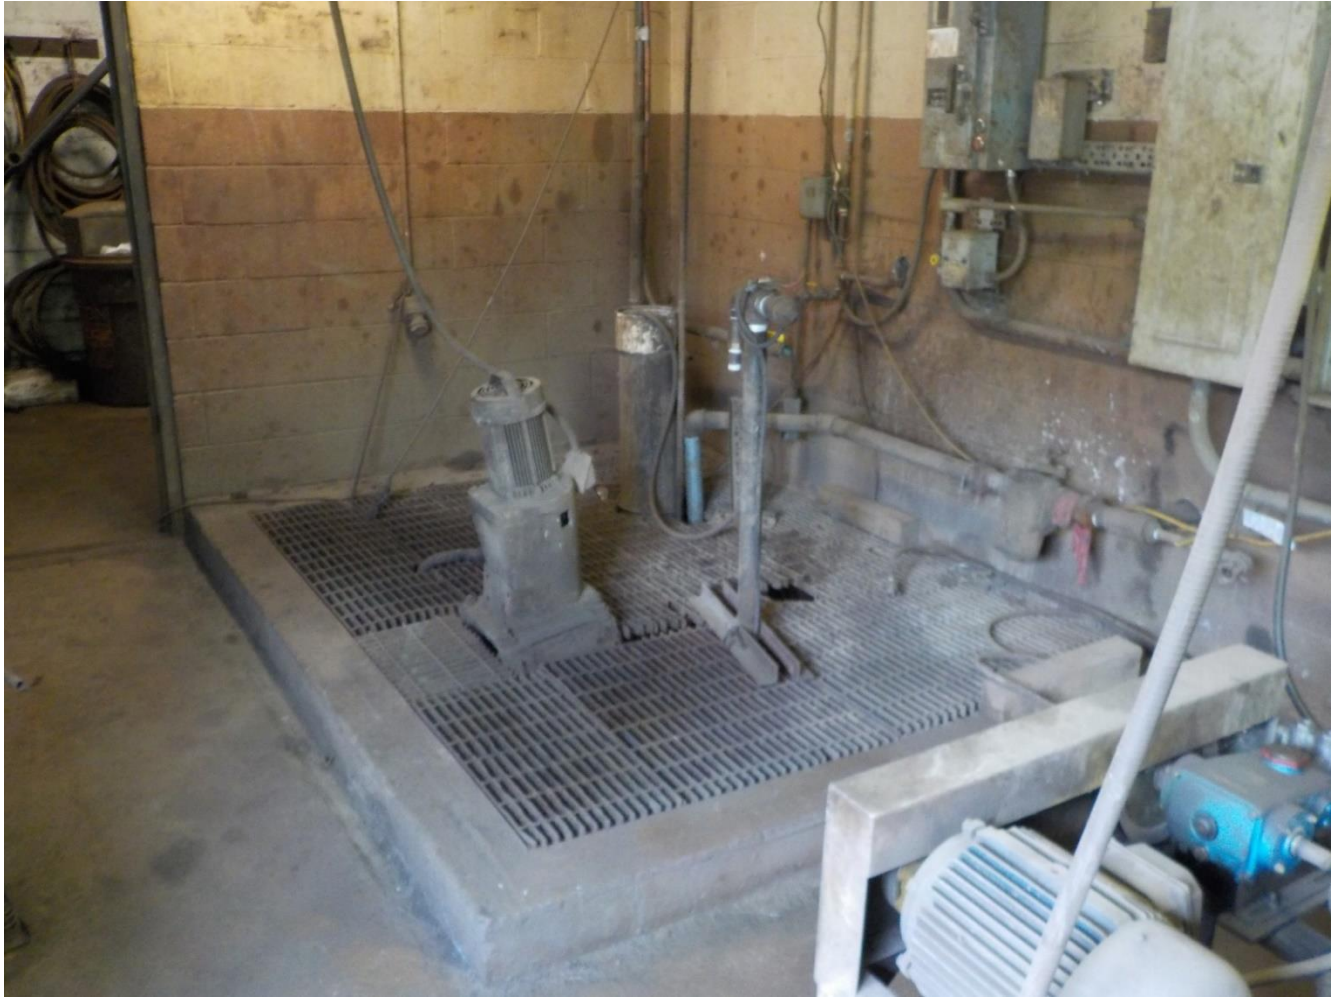
Photo 30. (DSCN0179) This photo shows the top of the concrete pit that contains the round, open-top holding tank for dirty wash water from the truck wash bays (Building 624). Appurtenances visible above the metal grates covering the pit include an agitator, the inflow pipe, and a pump that moves the dirty wash water to the water cannon in Building 608. See also Photo 31.

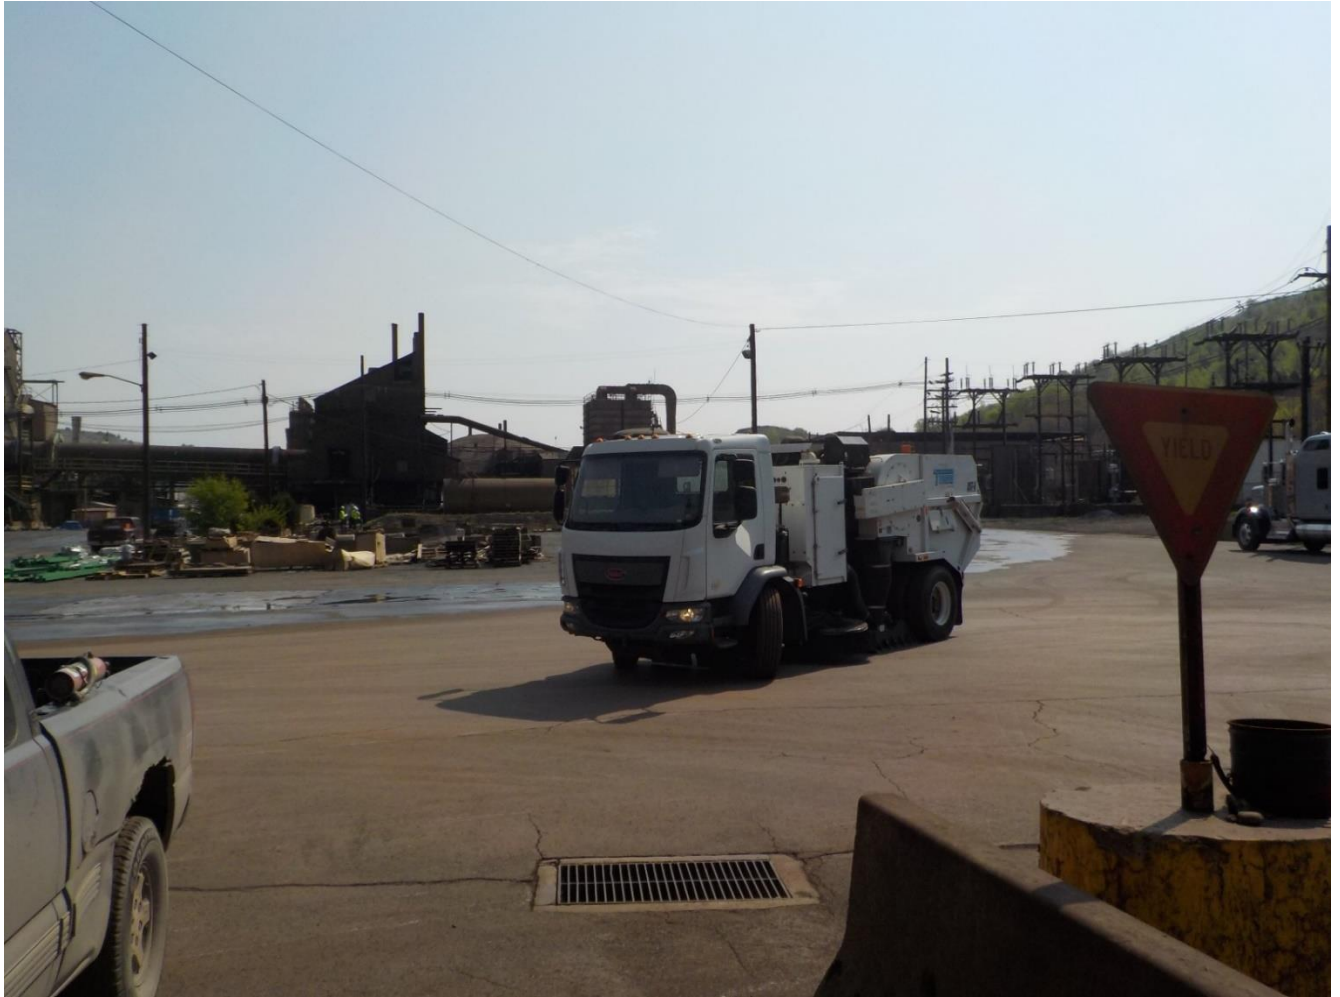
Photo 32. (DSCN0171) This photo, taken outside the truck wash bay exit doors, shows a Facility street sweeper operating on paved areas.

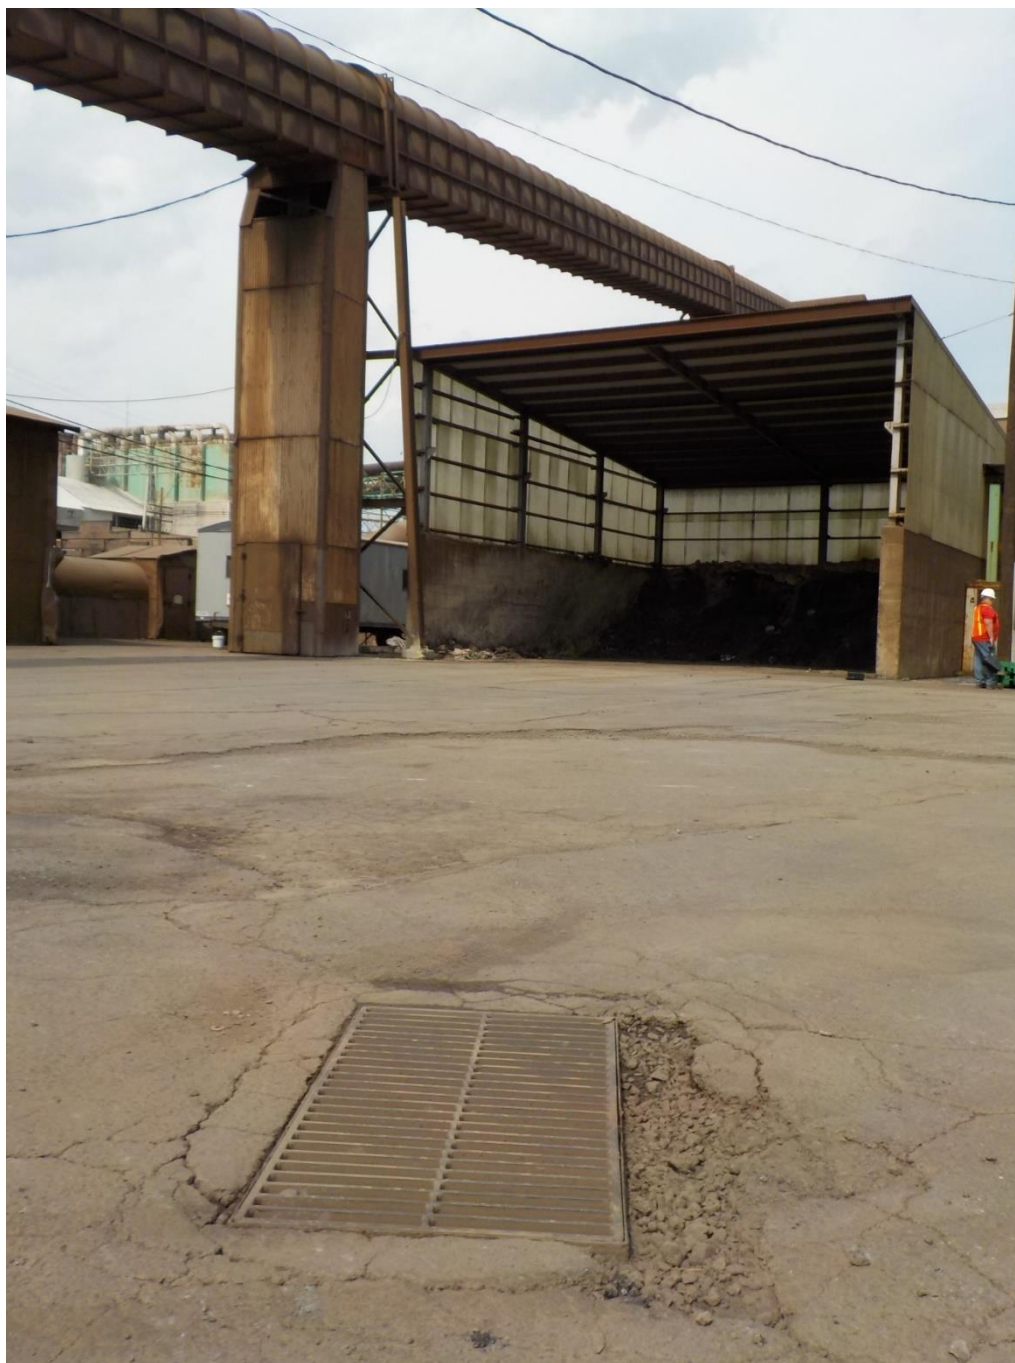
Photo 33. (DSCN0254) This photo looks eastward towards the Lime bunker where kiln rubble is accumulated. Catch basin 9, the western terminus to storm sewer lateral 4, is in the foreground. See also Photos 34 and 35.

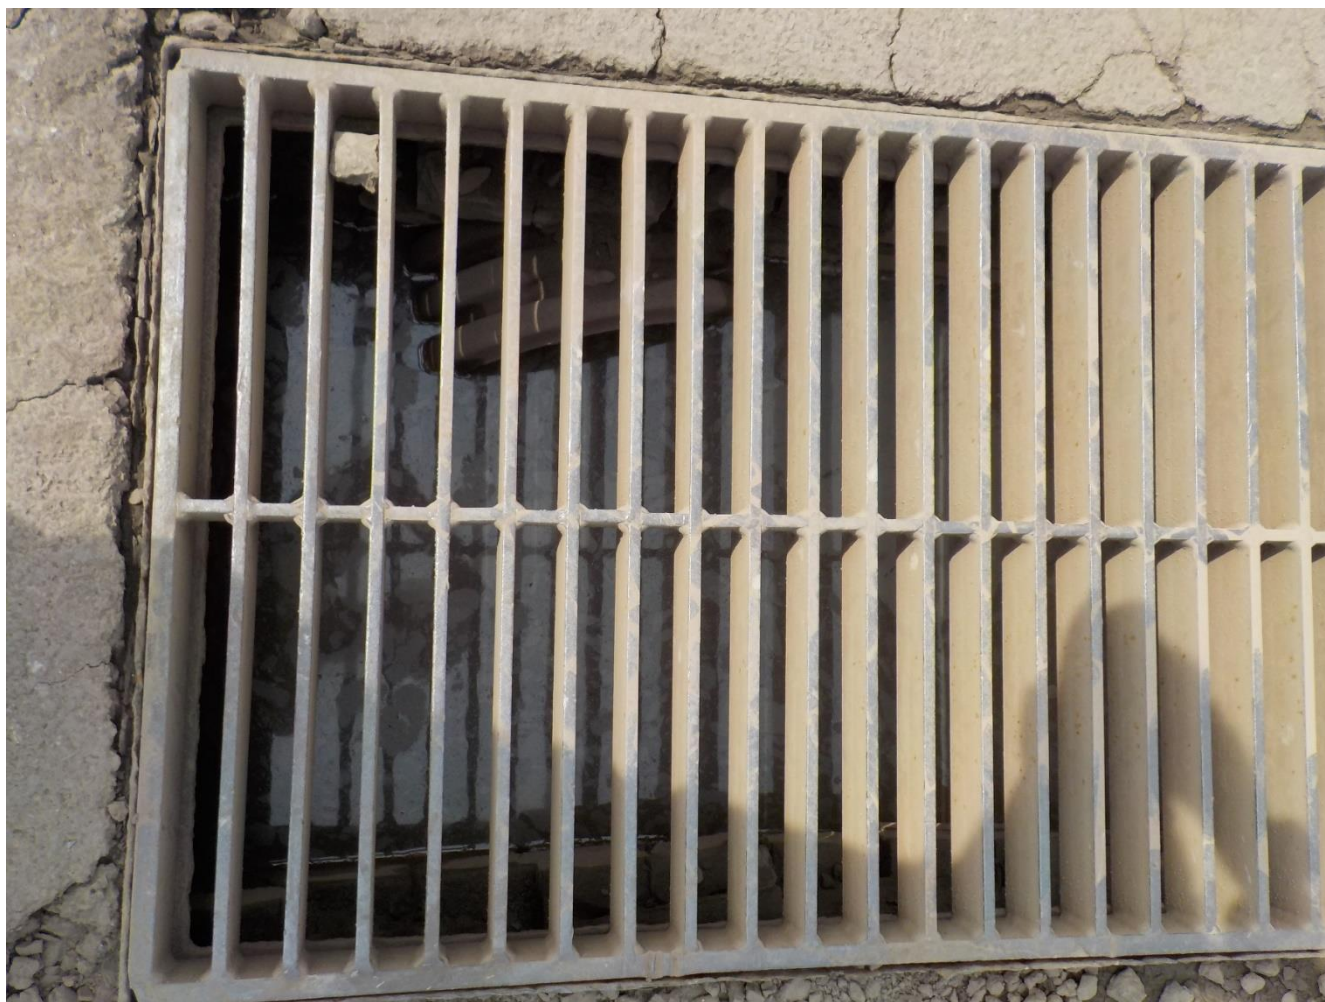
Photo 34. (DSCN0255) This photo shows a close-up view of the inlet to catch basin 9, located in the paved area between Building 624 (truck wash bays) / 608 (EAF dust storage) and the Lime bunker. See also Photo 33. Note, the catch basin contains brown water and the outflow pipe is partially submerged.

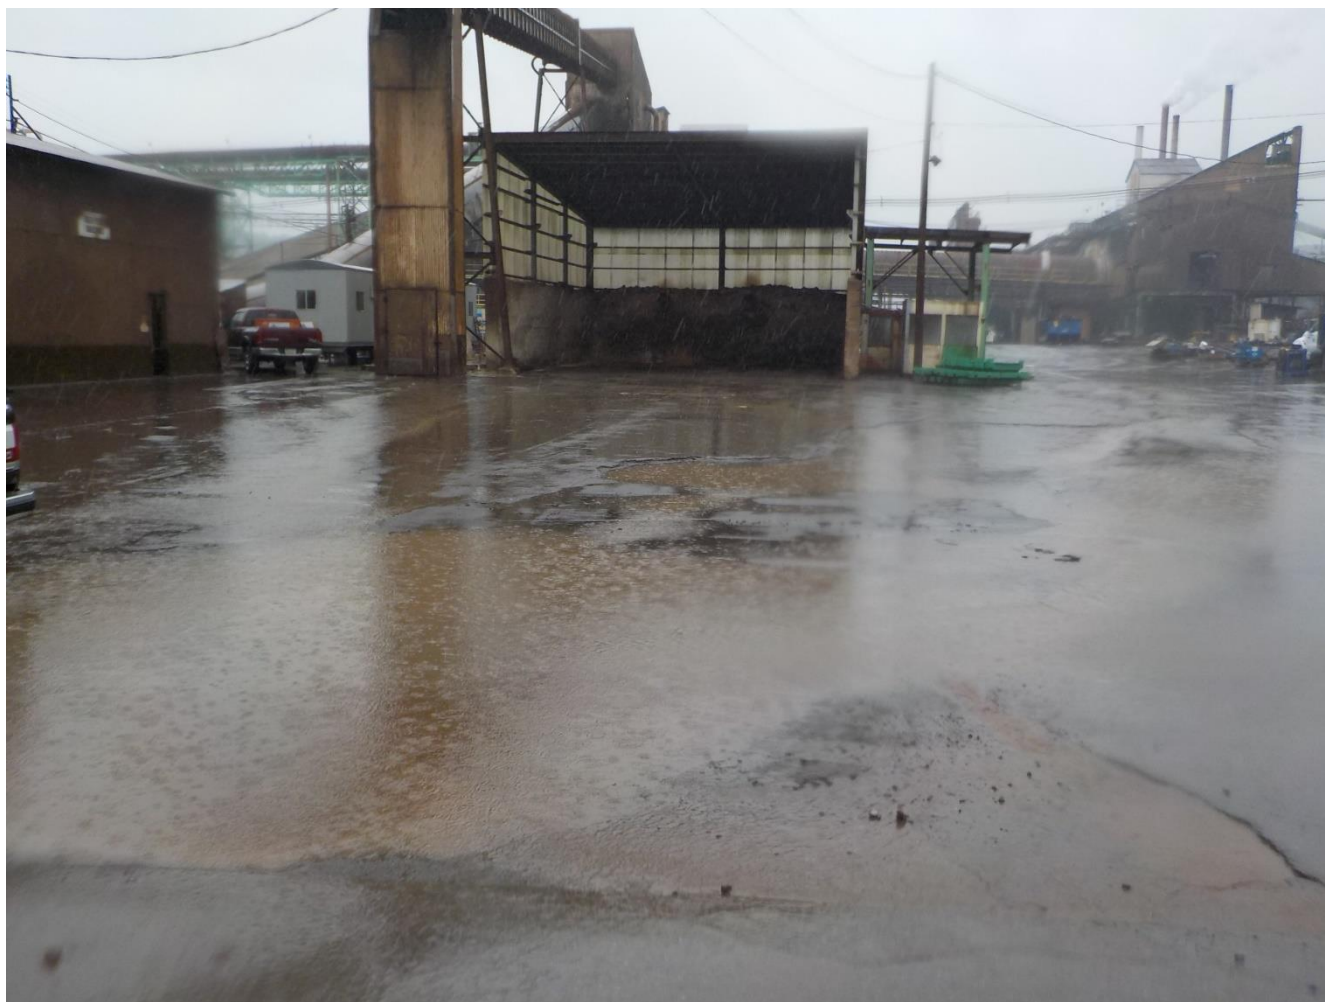
Photo 35. (DSCN0359) This photo, taken during rainy weather on 16 May, 2018, shows the puddle of storm water in the paved area between Building 624 / Building 608 and the Lime bunker. See also Photo 33. Note, the inlet to catch basin 9 is not visible in this photo.

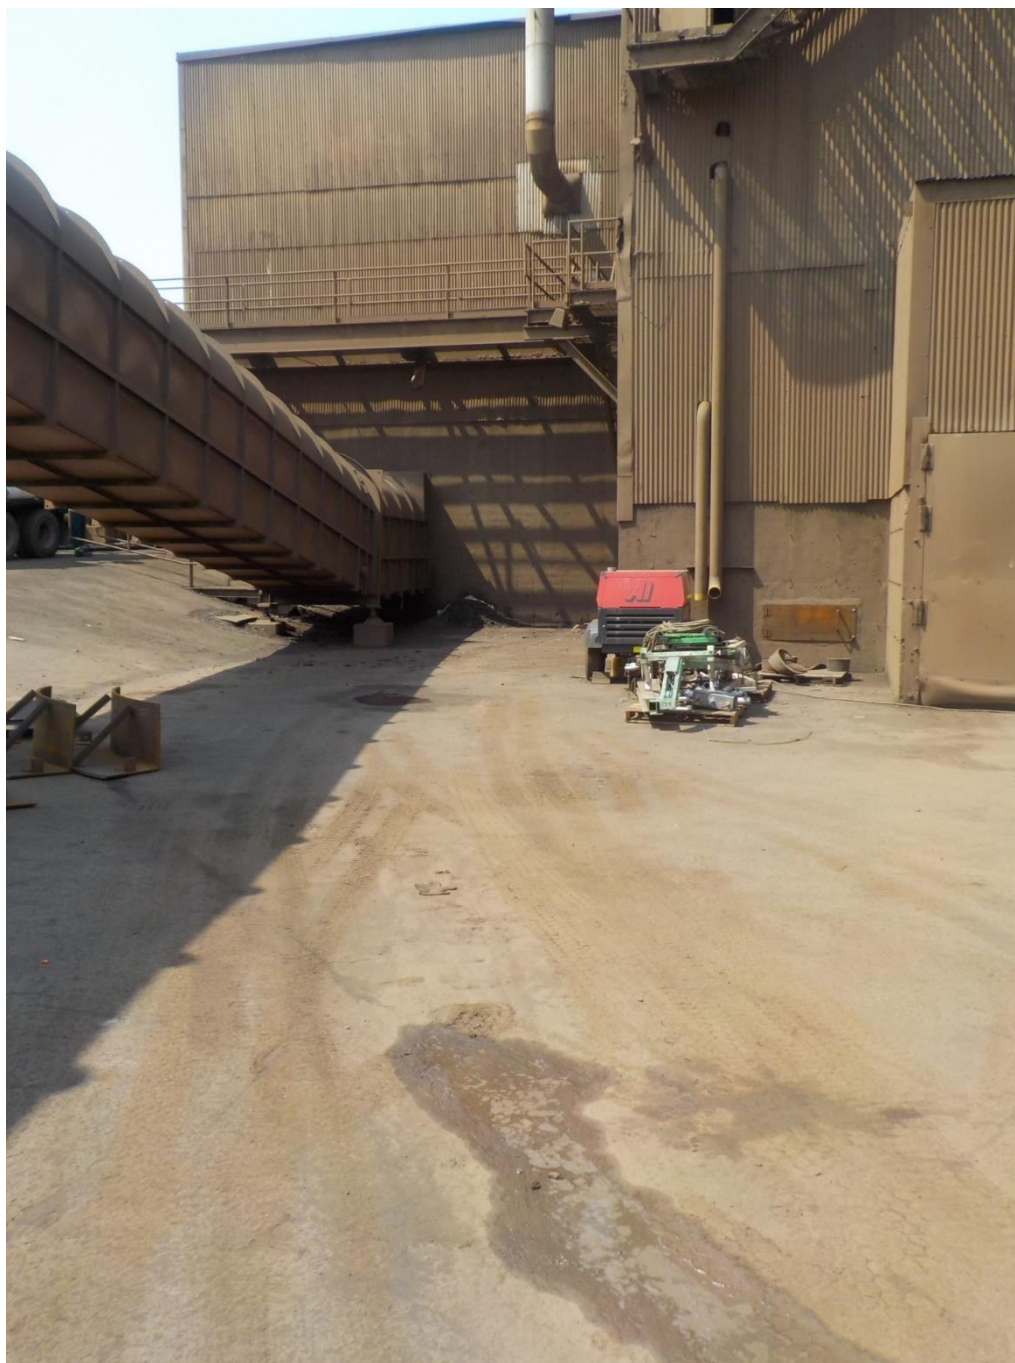
Photo 36. (DSCN0207) This photo looks westward towards the pelletizer building and the base of one of the “gallery belts” that take pelletized EAF dust and coke to the kiln feeds. Note the puddle of brown, cloudy water and fine-grained brown sedimentary material present on the pavement. See also Photos 37, 38, 39, and 40.

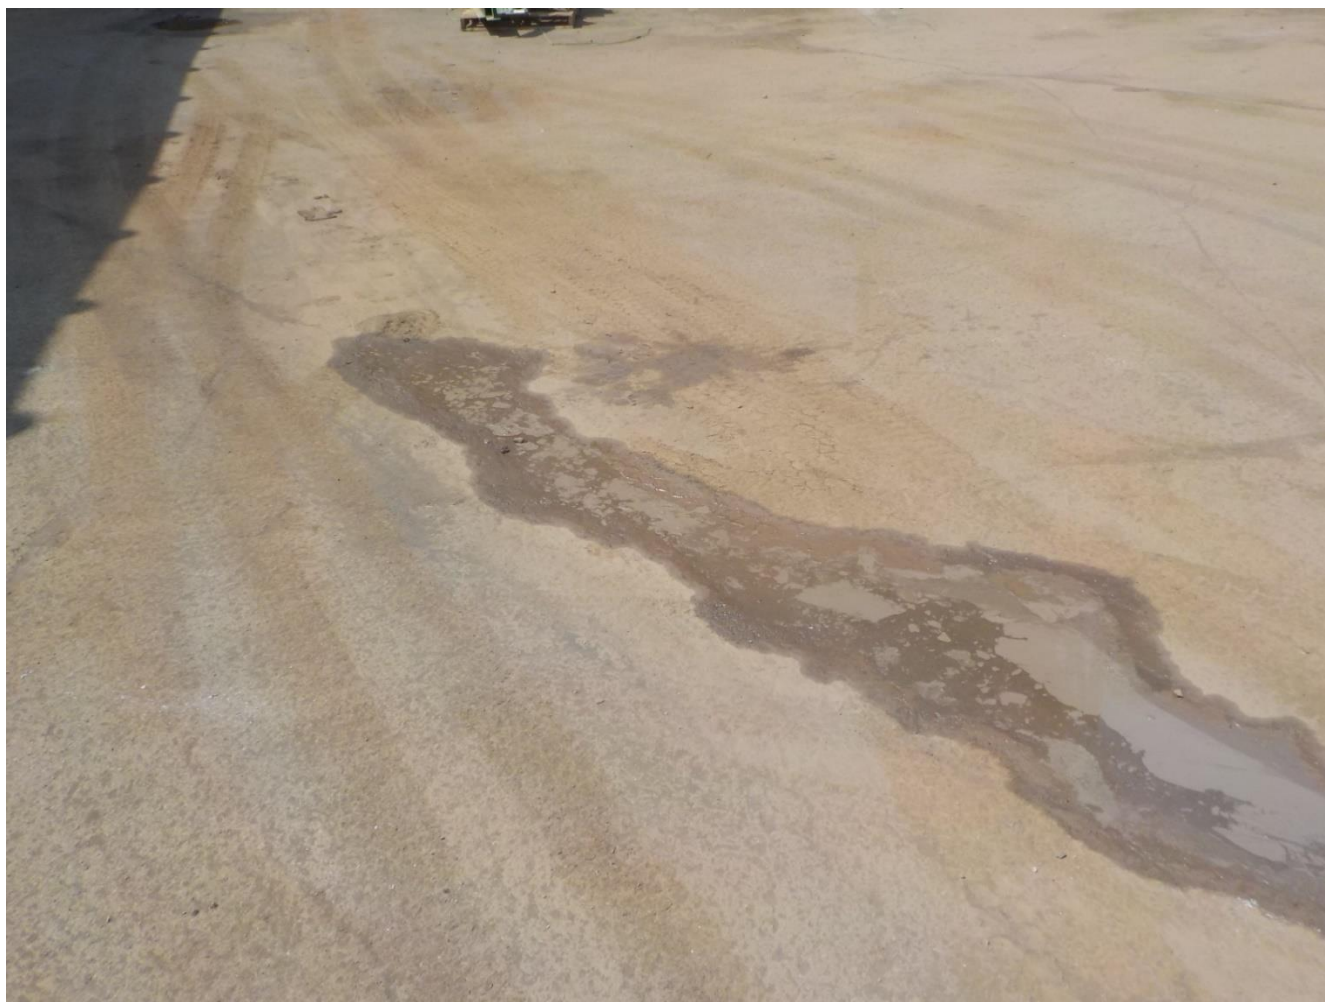
Photo 37. (DSCN0208) This photo shows a closer view of the puddle of brown, cloudy water with suspended sedimentary material seen in Photo 36. See also Photos 38, 39, and 40 for a pan to the right following the path of the water.

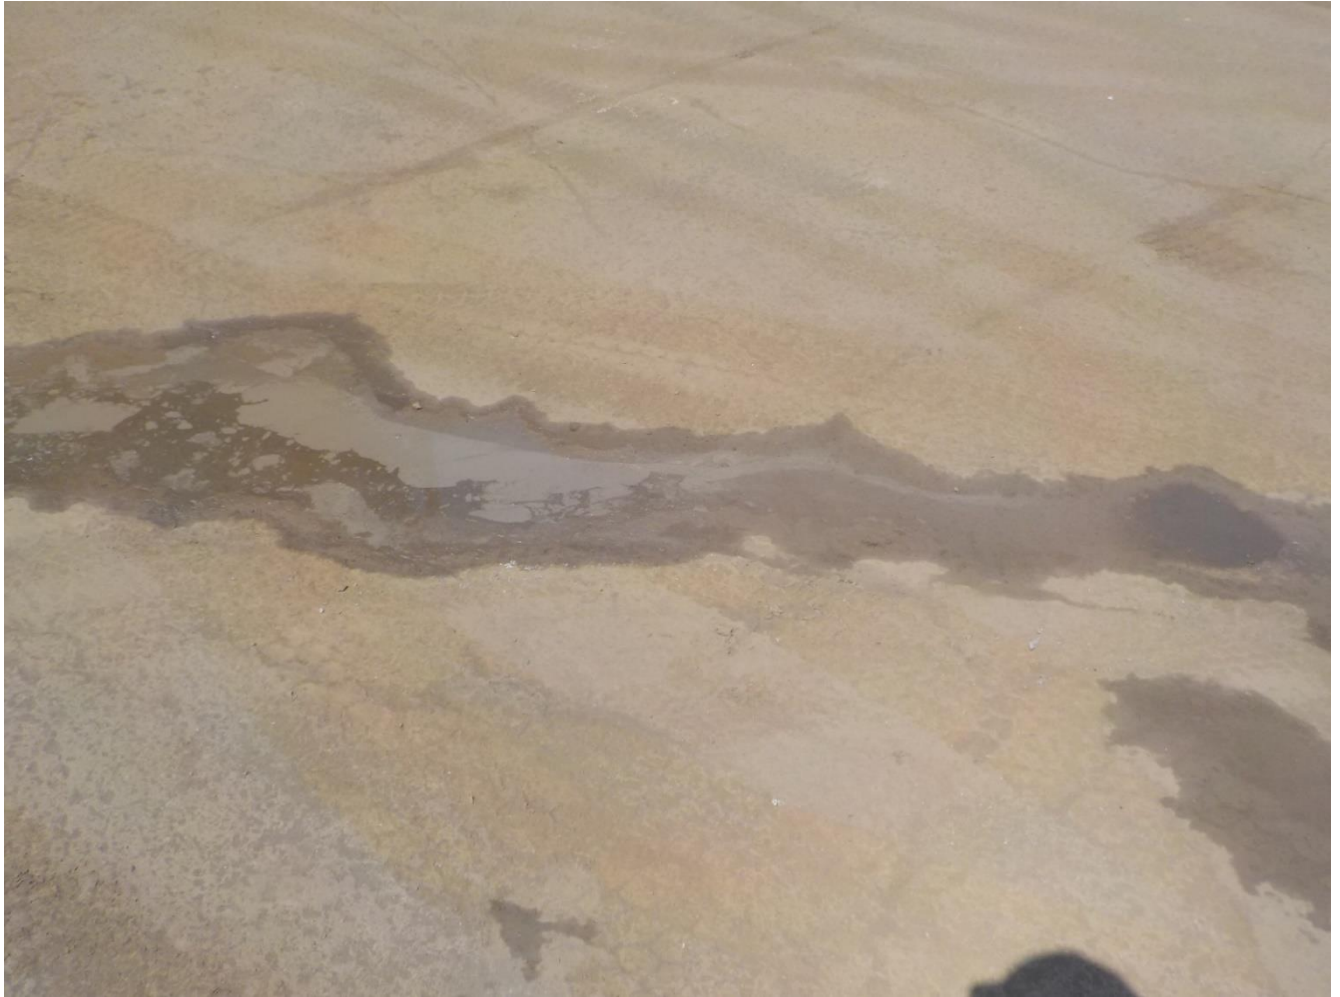
Photo 38. (DSCN0209) This photo is the first in a series of photos panning right to follow the path of the brown, cloudy water shown in Photos 36 and 37. See also Photos 39 and 40 to continue panning right.

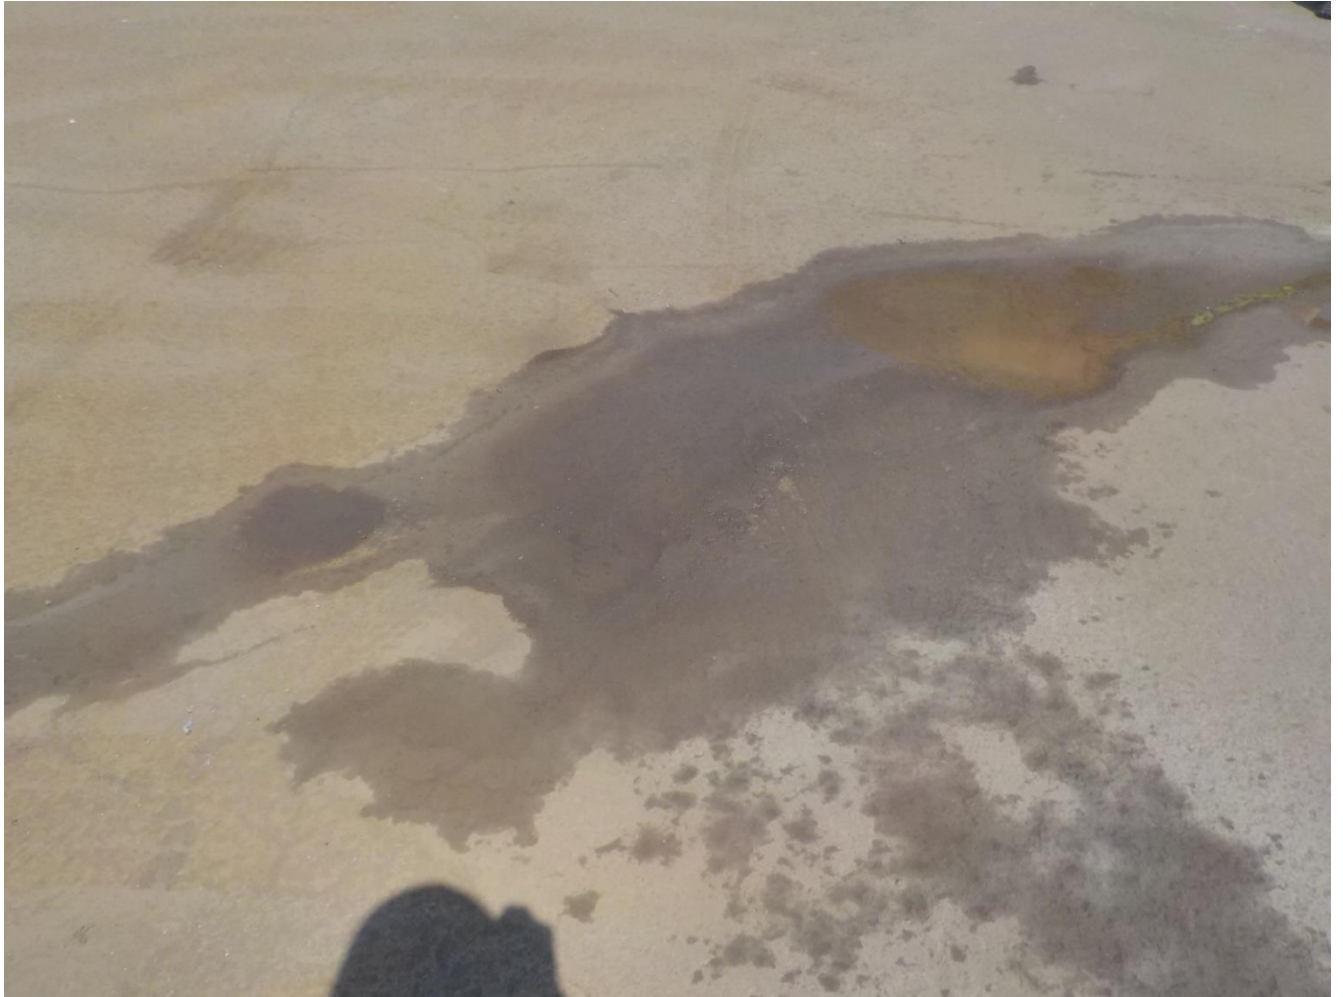
Photo 39. (DSCN0210) This photo is the second in a series of photos panning right to follow the path of the brown, cloudy water puddle shown in Photos 36 and 37. See also Photo 40 to continue panning right.
